IMPORTANT SAFETY RECALL RECALL NO. 23E038

June 2023

This recall involves Carquest-branded lower ball joints (pictured below), part numbers 410-234673 and 410-234674, for installation in certain Volkswagen and Audi vehicles.

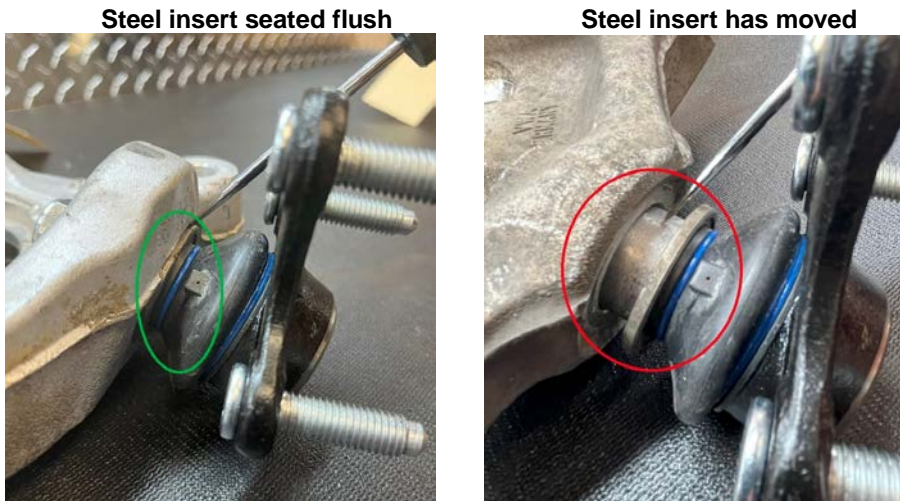
The ball joint stud may pull out of the aluminum steering knuckle. If the ball joint separates from the knuckle, then front wheel control may be compromised, increasing the risk of a vehicle crash.

- Take your vehicle to your preferred repair shop and present this letter to the service advisor so they are aware of the issue and repairs to be performed.
- Have the repair shop inspect the knuckle to determine if the steel insert that is pressed into the aluminum knuckle where the ball joint stud mounts is still fully seated into the knuckle. The bottom

of the steel insert should be flush with the bottom of the aluminum knuckle. See images below:

- If the steel insert has moved such that it is no longer fully seated inside the knuckle (right photo above), the repair shop should replace *the complete knuckle assembly, lower ball joint and lower ball joint stud nut* with the following OE parts:

- OE aluminum steering knuckle
 - OE lower ball joint
 - OE lower ball joint stud nut
- If the steel insert is still fully seated inside the knuckle (left photo above), the repair shop should *replace only the lower ball joint stud nut* with the following OE part:

- OE lower ball joint stud nut
- Because Carquest-branded replacement parts are not currently available, the repair shop will need to source the OE parts for the repair from its local Volkswagen/Audi dealership.
